Analysis of In-Depth Crash Data on Indian National Highways and Impact of Road Design on Crashes and Injury Severity

Abstract – The National Highways Development Project in India is aimed at upgrading over 12,000 km of national highways from 2-lane undivided roads to 4-lane divided roads. With nearly 40% of fatal crashes being reported on national highways, the effect of this project on road safety needs to be assessed. Researchers carried out on-site crash investigations and in-depth crash data collection for a period of 45 to 60 days on four 2-lane undivided highways and a 4-lane divided highway. Based on 76 crashes examined, researchers found a shift of crash pattern from head-on collisions on undivided 2-lane highways to front-rear collisions on divided 4-lane highways. This paper presents the methodology, analysis of crashes examined, and the critical safety problems identified for greater consideration in future highway development projects. This paper also highlights the need and significance of in-depth crash investigations to understand local traffic conditions and problems in India.

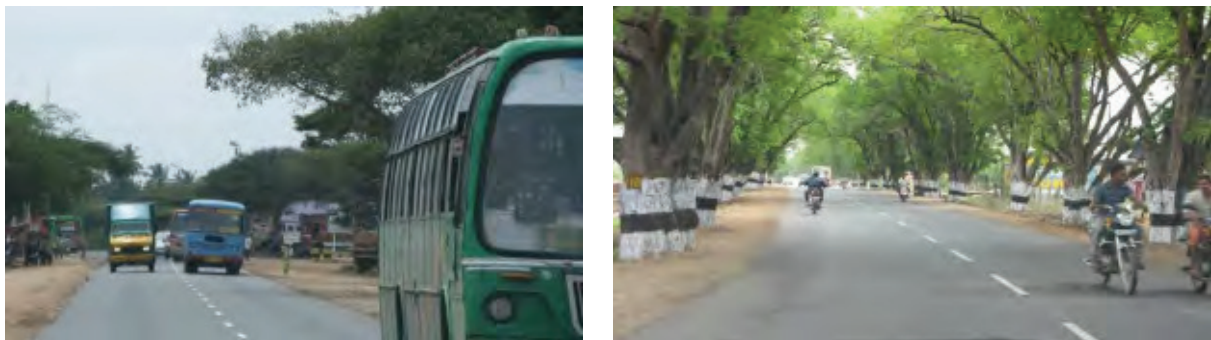
Figure 2. Typical Sections of NH47 (left) and NH209 (right).

The NH47 has a high volume of traffic during the day as the highway connects major industrial areas with Coimbatore city. NH209 is relatively less busy as compared with NH47. Both the highways are narrow and, as can be seen in Figure 2, have no paved shoulders. The most prominent difference between the NH47 and NH209 is the presence of trees alongside the entire stretch of NH209. Also unlike the NH47, which has many straight stretches, the NH209 highway has many curves and fewer straight stretches. There are also a number of junctions where narrow village roads join the NH209. Most of the highway stretch is not lit at night. Lighting is provided only at junctions.

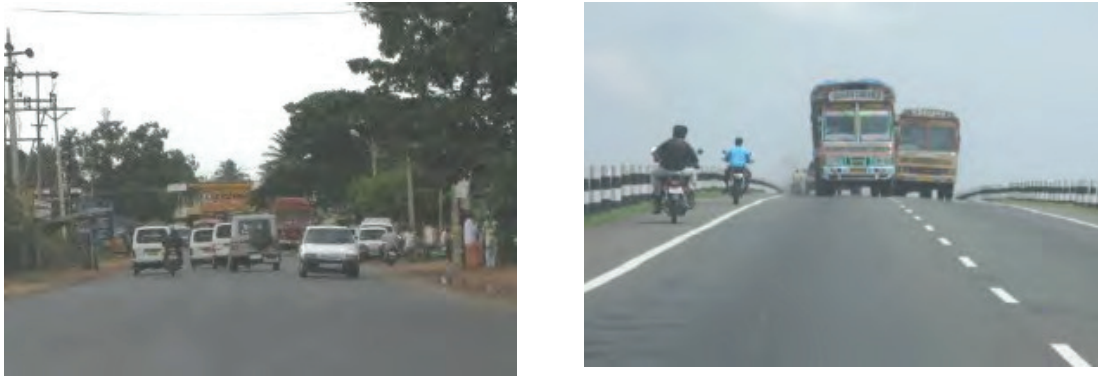
Figure 3. Typical Sections of NH67 (left) and NH47 Bypass (right).

Both, the NH67 and NH47 Bypass, are undivided highways, but are wider than the NH47 and NH209 due to the provision of a paved shoulder of 1.5 metres along the entire stretch of both highways. The most prominent difference between the two is the presence of concrete poles all along the NH47 Bypass, as can be seen in Figure 3. These poles, placed at regular intervals of 3 metres, are provided for delineation. The NH47 Bypass also has a number of intersections with narrow village roads, while the NH67 passes through a town and has many places of interest (temples, schools, shops) adjacent to the road. While lighting is provided at many sections of the NH67, the NH47 Bypass is completely

unlit. An important observation was that motorized two-wheeler riders, especially on the NH47 Bypass, used the shoulder as their lane.

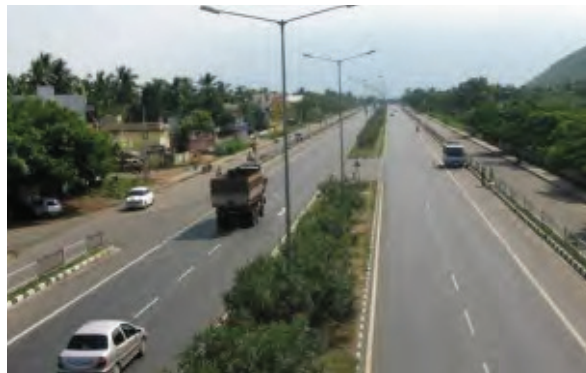
Figure 4. Typical Section of NH45 with Wide Median and Paved Shoulders.

The NH45 was developed from a 2-lane highway to a 4-lane highway under the NHDP, as shown in Figure 4. The median is about 5 metres in width and is usually planted with large bushes and plants. A paved shoulder of 1.5 metres is provided along the entire length of the highway. Speed limit at some sections is specified as 60 kmph and at others is 80 kmph. However, actual travel speeds are observed to be much higher. Lighting is provided only at intersections/junctions and some areas such as truck lay-bys. Otherwise, a good part of the highway is not lit.

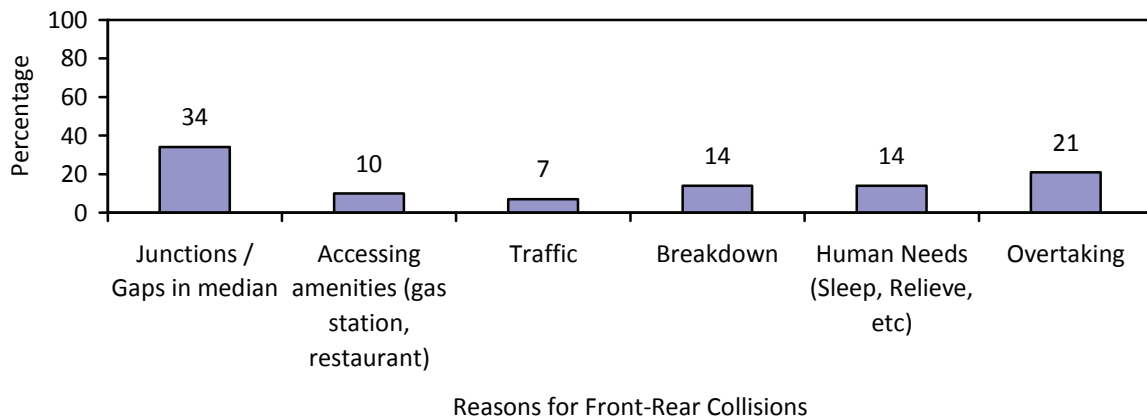
Figure 5. Distribution of Front-Rear Collisions by Reason for Collision.

Researchers determined that in 51% of the crashes, the vehicle in the front was moving slower than the vehicle behind, and in 28% of the crashes, the vehicle in front was stationary/parked. Crashes due to overtaking carelessly constituted 21% of front-rear collisions. Researchers analyzed the pre-accident conditions of vehicles in the front to determine reasons for slowing down or being stationary. Figure 5 shows the reasons identified.

It was observed that vehicles usually moved slowly while approaching or moving away from junctions or gaps in the median (34%), or while entering or exiting the highway to access gas stations, restaurants, etc. (10%), or due to traffic congestion (7%). Road design at junctions/gaps in median, entry and exits of highway amenities, and the availability of clear signage and advance warning to drivers needs to be looked into.

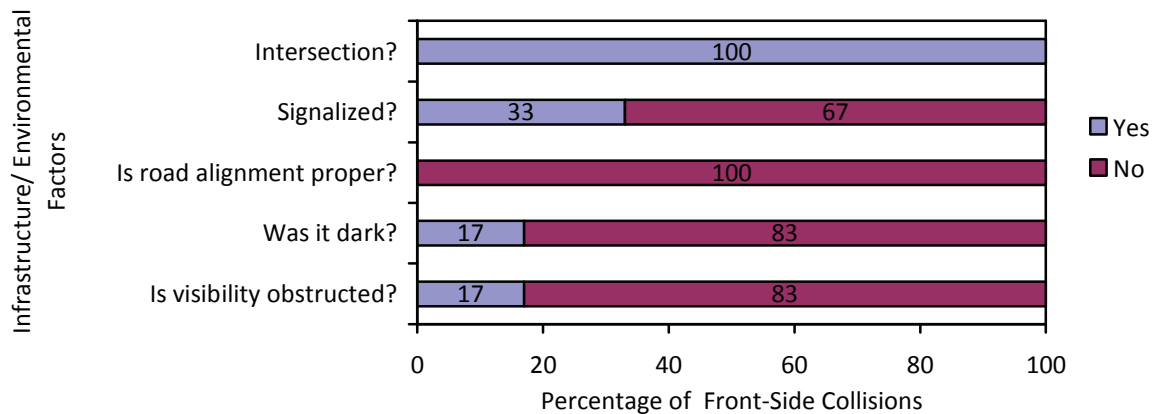
Figure 8. Distribution of Infrastructure/Environmental Factors in Front-Side Collisions.

When the front-side collisions were analyzed for common problems, road alignment and design came out to be the most predominant factor involved, as shown in Figure 8.

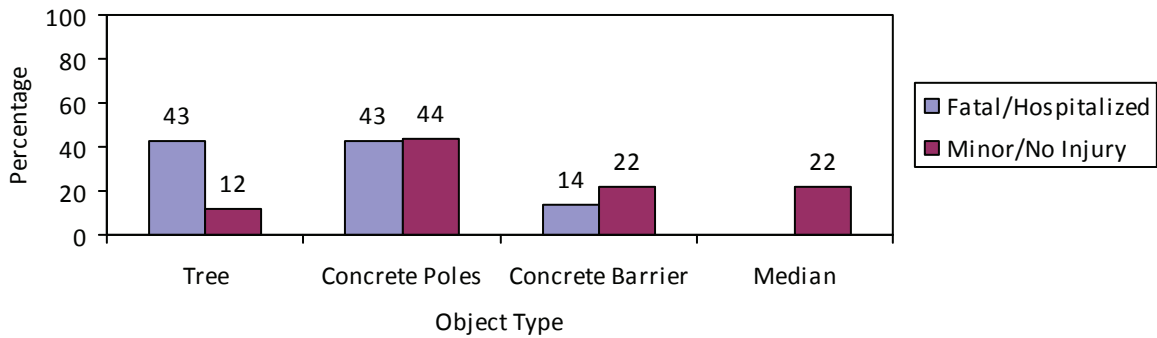
Figure 10. Single Vehicle Crash Types and the Resulting Injury Severity.

The presence of a road-side object was the main contributor to these crashes. Trees were the natural objects involved in these crashes. However, 75% of object impacts involved man-made objects such as concrete poles, concrete barriers and raised median. The severity of the crash depended on the rigidity of the object to the vehicle striking it. As can be seen in Figure 10, 86% of object impacts causing fatal/hospitalized injuries involved hitting a tree or concrete pole located alongside the road.

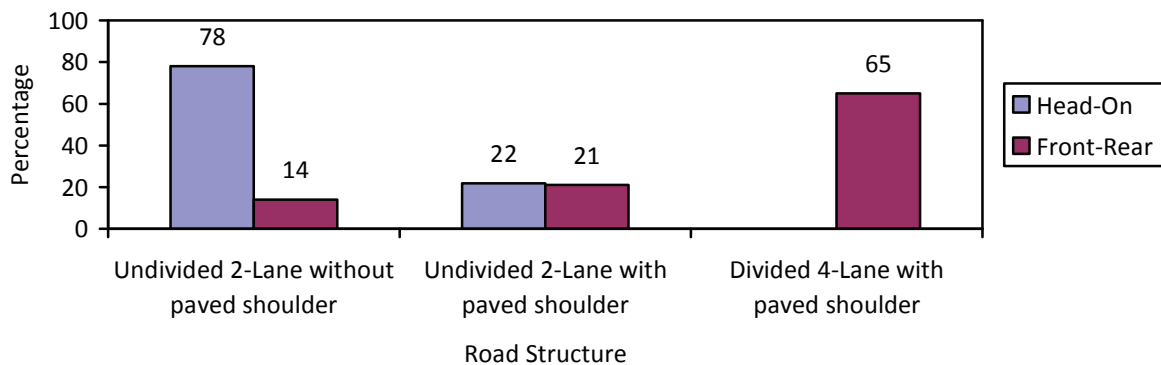
Figure 12. Distribution of Front-Rear and Head-On Collisions by Road Structure.

Undivided 2-lane highways without paved shoulders had 78% of head-on collisions, while the divided 4-lane highway had 65% of the front-rear collisions. It can be observed that there is a clear shift of crash pattern from head-on collisions to front-rear collisions when the highway structure is changed from undivided 2-lane to divided 4-lane.

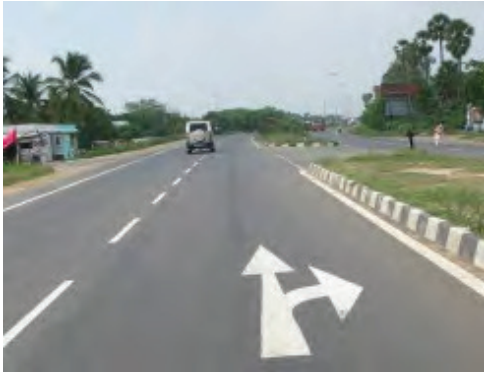
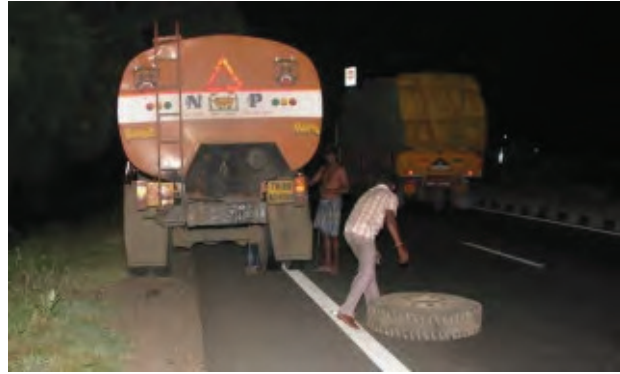
Figure 13. Vehicles Proceeding Straight or Taking a Turn Share the Same Lane at a Gap in Median (left); and a Truck Parked Partly on the Road for Repairs (right).

Locations such as gaps in median and road junctions were the reasons for vehicles slowing down and causing 34% of the front-rear collisions. As can be seen in Figure 13, these areas need to be redesigned for providing proper acceleration/deceleration and storage lanes, especially for heavy vehicles, so that vehicles intending to take a turn, exiting or entering the highway can be separated from faster moving traffic on the highway.

Insufficient shoulder width was the reason for vehicles stationary on the road and causing 28% of the front-rear collisions. Heavy vehicles, particularly trucks, were observed to have been stopped/parked on the road due to the shoulder width of 1.5 metres being less than the vehicle width.

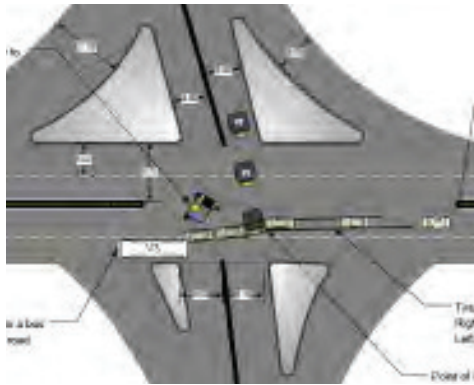
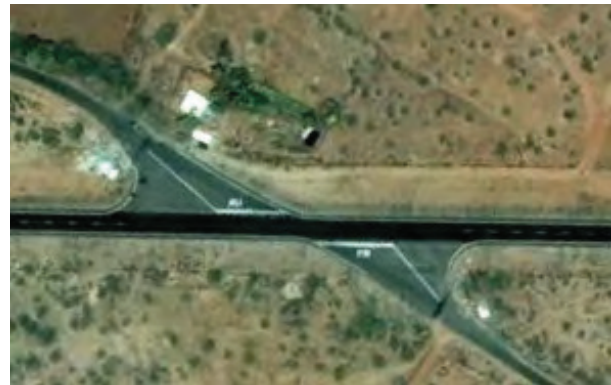
Figure 14. Intersections with Poor Road Alignments on the NH67 (Scene Diagram on the left) and NH47 Bypass (Google Earth Image on the right).

Poor alignment of intersecting roads (as shown in Figure 14) was the predominant factor in front-side collisions.

Hence, 4-way intersections and junctions need to be designed with better road alignment and proper channelling to separate the traffic departing/joining/crossing the highway from traffic continuing on the highway.

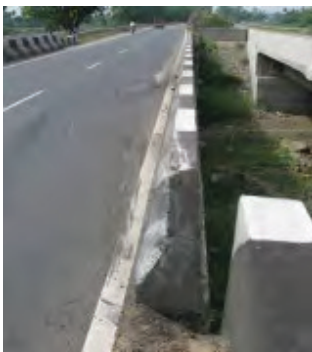
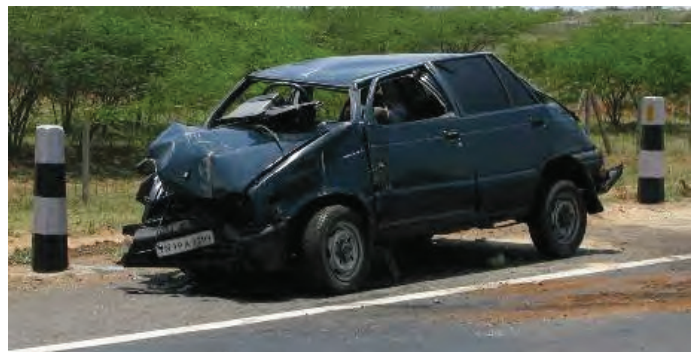
Figure 15. An Open Ended Bridge Wall Built Very Close to the Roadway (left) was the Cause of a Truck Crash; and a Crashed Car which Impacted the Concrete Poles (right).

Although trees along the road-side are significantly less in the new divided 4-lane highways, object impacts with delineators (concrete poles) and bridge walls, as shown in Figure 15, remain a concern. These objects need to be well away from the roadway and should also be crash protective in design.
